*White Paper:*  
*Achieving Hot Bitumen Safety*

## **Hot Bitumen Safety – Still an Issue, Ten Years On**

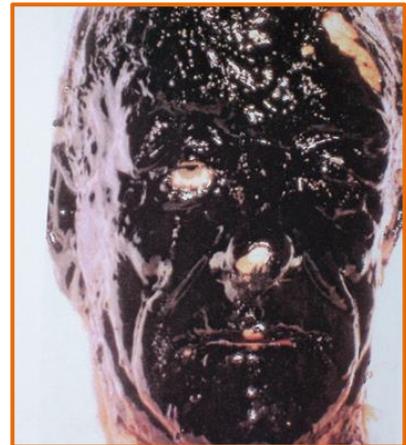
There are over 300 asphalt manufacturing plants in the United Kingdom, with a total of approximately 1300 bitumen storage tanks. Bitumen is pressure-delivered hot (up to 230°C) and must be stored at a constant high temperature (ranging from 125-190°C depending on the grade and type of product). As a result, spillages from these tanks as a result of overfilling have a high potential for serious injury (*as pictured right*).

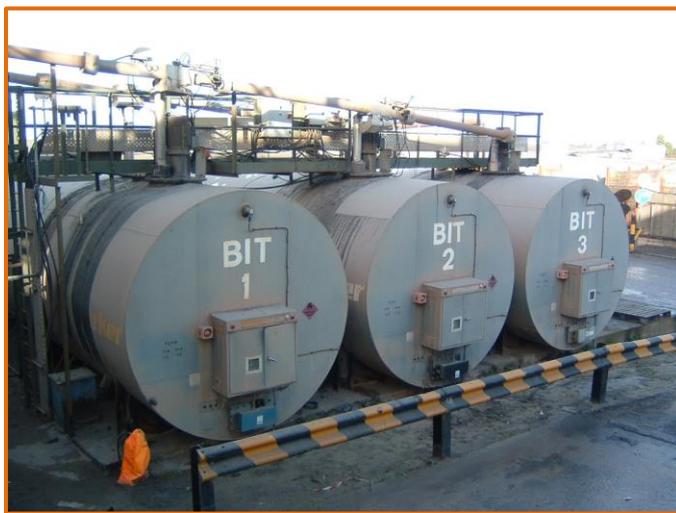
It is believed that at least 90% of bitumen accidents can be attributed to the simple problem of drivers and site staff not understanding the ‘true’ available tank capacity – i.e. the actual amount of storage space available for the bitumen product being delivered. Whilst a vessel may be declared to have a certain capacity, there will always be a certain space at the bottom of the tank below the draw-off point which will

never be drained, and so must be discounted. Similarly (and though it seems obvious it is frequently not considered) it would not be possible to fill the tank above the overfill pipe – reaching and exceeding that level will result in a spill. Despite this the unavailable space above the overfill point is still included in the vessel’s nominal capacity.

Therefore it is a vitally important safety issue that staff be aware of the difference between a tank’s declared capacity and its actual safe working capacity (which is itself 90% of the available tank capacity). In parallel, it is vitally important that staff have an accurate measurement of the actual tank contents at the time of delivery (the tank may not be at its lowest point).

Consider the following example of a newly-installed bitumen tank with a stated capacity of 100 tonnes:

Nominal Tank Capacity [NTC]	105.8 m <sup>3</sup>	97.3 tonnes
Unavailable Tank Capacity (top and bottom) [UTC]	5.3 m <sup>3</sup> + 1.0 m <sup>3</sup> = 6.3 m <sup>3</sup>	5.8 tonnes
Available Working Capacity [AWC = NTC – UTC]	99.5 m <sup>3</sup>	91.5 tonnes
Safe Working Capacity [SWC = AWC x 0.9]	89.6 m <sup>3</sup>	82.4 tonnes

Therefore of a stated capacity of 100 tonnes, only 82.4 tonnes can safely be stored. It is little wonder then that misunderstandings of capacity are commonplace, and are the leading cause of bitumen spillages.

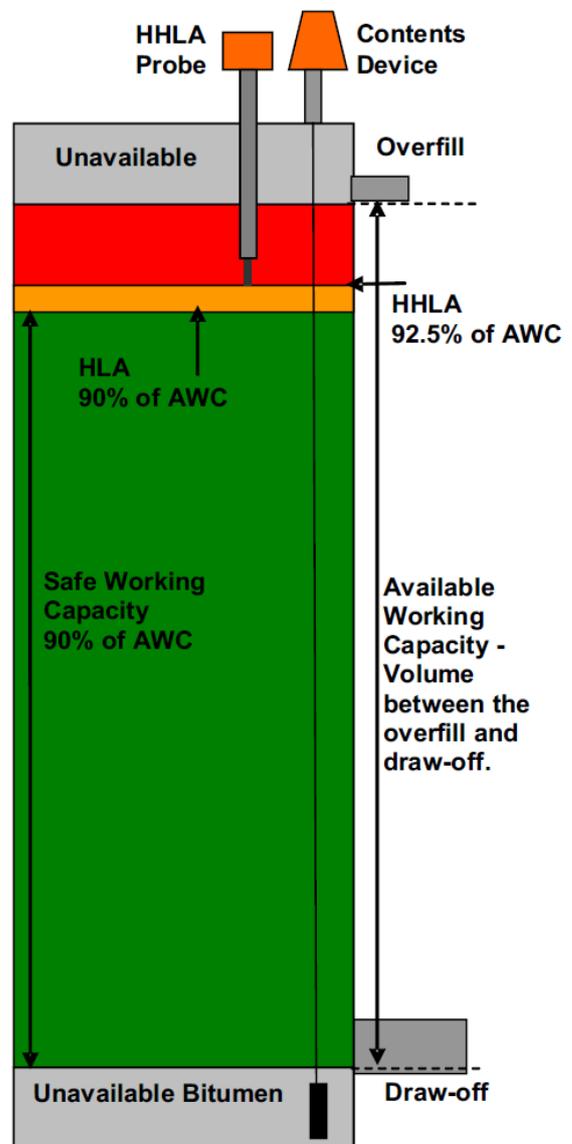
Having been consulted by the RBA throughout the compiling of their guidelines, Hycontrol are better placed than most to point out shortcomings in bitumen level safety at sites they visit. With over thirty years of experience as an innovator in the level measurement field, the vital first step that Hycontrol advise is that sites ensure they have a ‘belt and braces’ approach to tank security. Indeed the RBA guidelines agree, stating that not only should all bitumen tanks be fitted with a reliable contents gauge that can trigger a HLA at 90% available tank capacity, but they also require a separate High High Level Alarm (HHLA) that is completely independent of the contents gauge and which will trigger at 92.5% available capacity. Only by doing this can site managers and staff begin to be truly confident of their ability to accurately judge tank contents and to avoid overfilling. The illustration to the right shows a typical ‘good’ tank set-up.

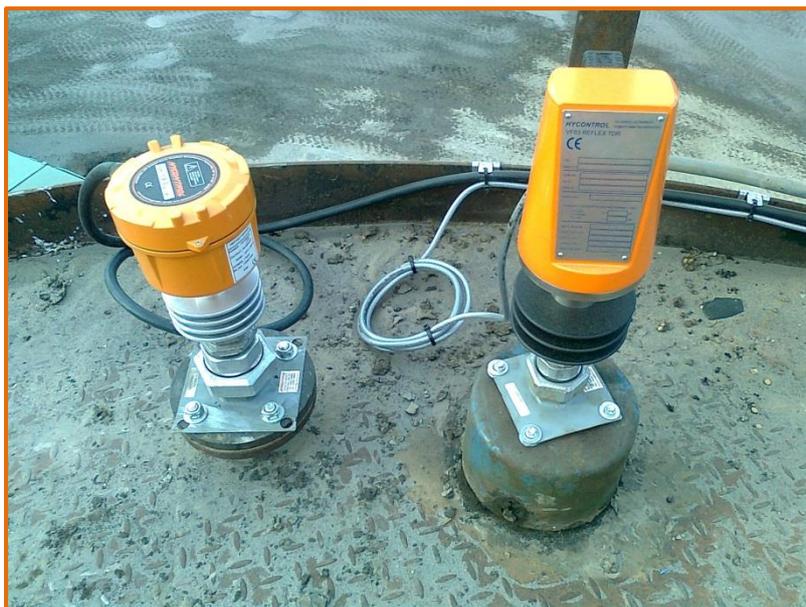
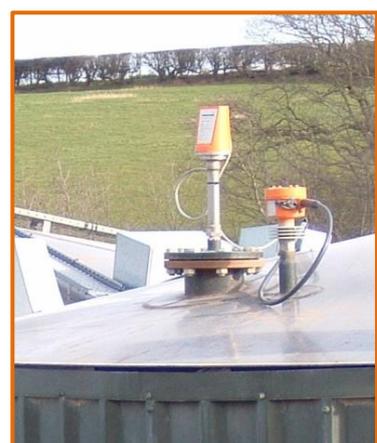
*Pictured: High-temperature Hycontrol TDR probe and RF Admittance switch in a bitumen application*

TDR technology, originally used to detect breaks in subsea communication cables, uses pulses of low power microwaves sent along the conducting probes. In a typical bitumen application, the stainless steel probes of the TDR sensor are fitted to flanges at the top of the tanks and extend down into the hot bitumen. The probes allow a very narrow measuring profile up to a maximum range of 24 metres and this is particularly useful for measurements in tanks which have internal structural supports.

At the point where the microwaves meets the air-bitumen interface, they are reflected by the bitumen back along the probe. The measured time between emission and reception back at the sensor head is proportional to the distance. This information is then converted to the level in the tank and a 4-20 milliamp signal, proportional to level or ullage space, is then fed to the displays in the external panel.

The advantage of this technology, which enables it to overcome the coating issue inherent in bitumen tanks, is that microwaves travel virtually at the speed of light and pass over any coating on the cable with negligible effect. Hycontrol have seen examples where a TDR cable has still operated reliably with a carbonised coating along virtually its entire length. Periodic cleaning is recommended as part of a site maintenance schedule in order to prevent the coating becoming too thick, but this need only be a couple of times a year. Performance is also not affected by changes in pressure, temperature, dielectric constant or viscosity, making TDR the perfect solution for hot bitumen.

Hycontrol's extensive site experience has shown that RF Admittance probes best suit the HHLA requirement as product build-up on the sensor does not impede its function. A protective insulation electrode between the conventional main electrode and the grounding sleeve allows the electronics to distinguish between coating and the actual product level. Again, whilst periodic cleaning is still recommended, utilisation of the correct equipment will have the added benefit of a vastly reduced maintenance requirement compared with old-fashioned measuring equipment. Admittance probes have no moving parts and so are not prone to wearing out like mechanical devices.

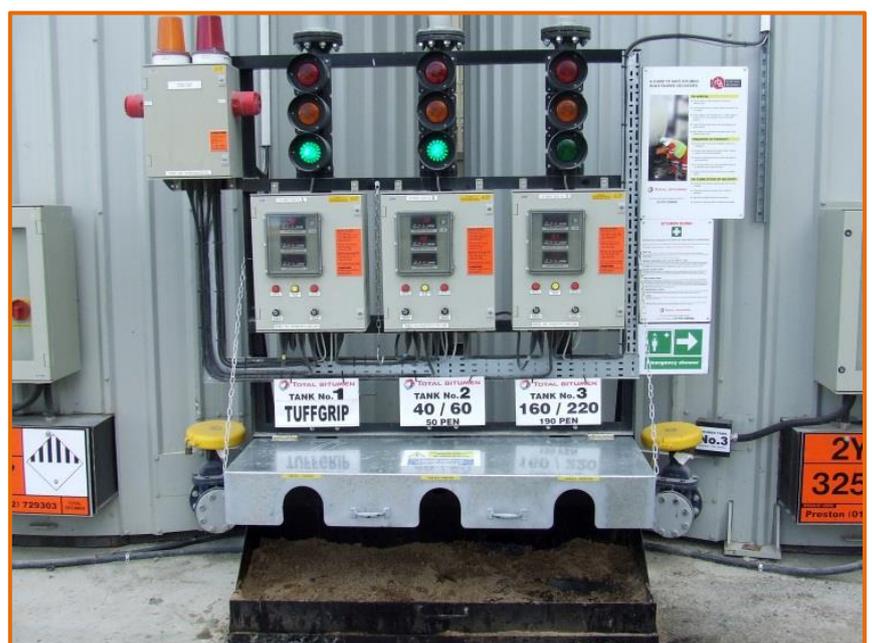
Finally, the Refined Bitumen Association guidance is clear on the need for visible, unambiguous display information for drivers and site staff. Panels should have very clear indication of the alarms and their status, along with flashing beacons and loud sirens to alert users when an alarm level is reached. This is vital to ensure tank integrity is maintained. In response to this requirement Hycontrol

manufacture a wide range of alarm and test panel solutions with easy-to-see level indicators for single and multi-point sites, all adhering to the RBA's recommendations. These can include displays of contents, ullage and tank temperature and have the option to integrate an independent alarm via a separate power supply to the panel.
